**BPG Inspection, LLC**

**2279 Columbia Drive  
Decatur GA 30032**

Client(s): Gumataotao  
Inspection Date: 4/11/2025  
Inspector: Colin Chandler ,

<b>Date:</b> 4/11/2025	<b>Time:</b> 10:00:00 AM	<b>Report ID:</b> 1087631
<b>Property:</b> 2279 Columbia Drive, Decatur, GA 30032		<b>Prepared By:</b> Colin Chandler

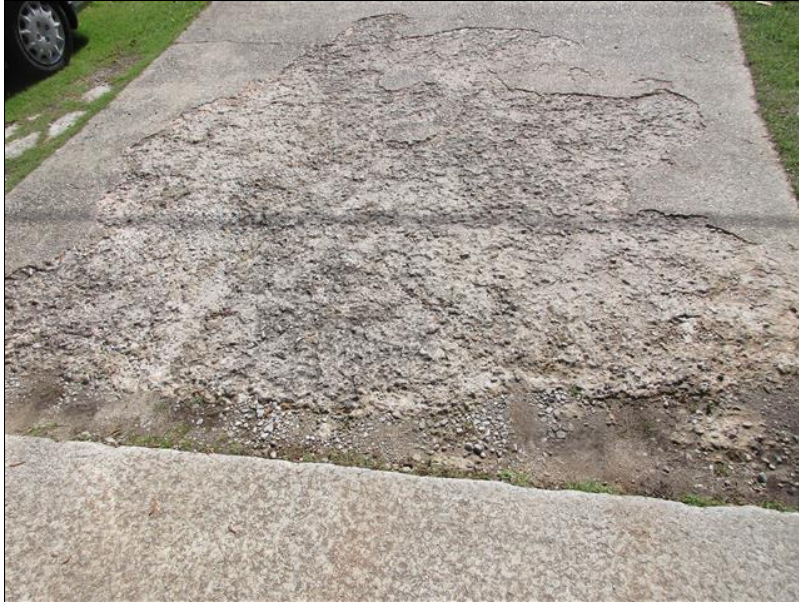
- ♦ **SERVICE / REPAIR:** Extensive cracking of the concrete driveway . Repair will be necessary. Recommend professional concrete contractor to repair / replace.

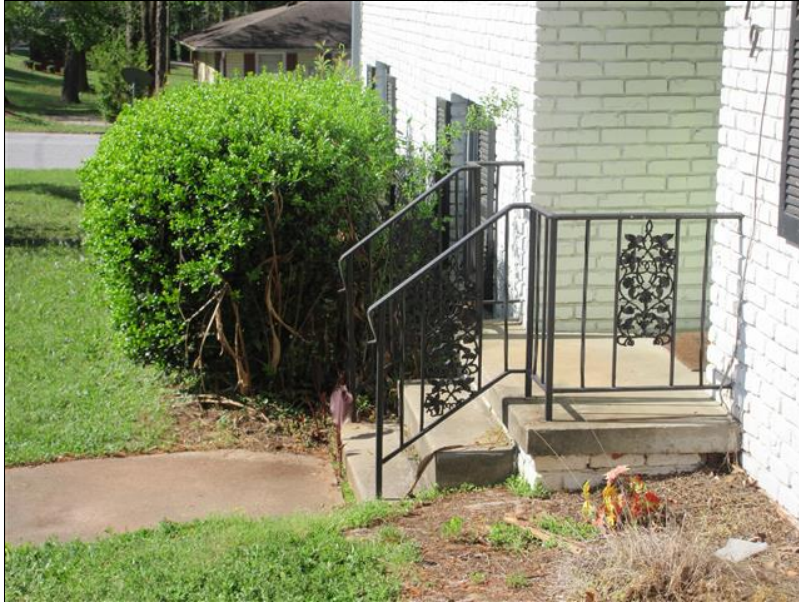
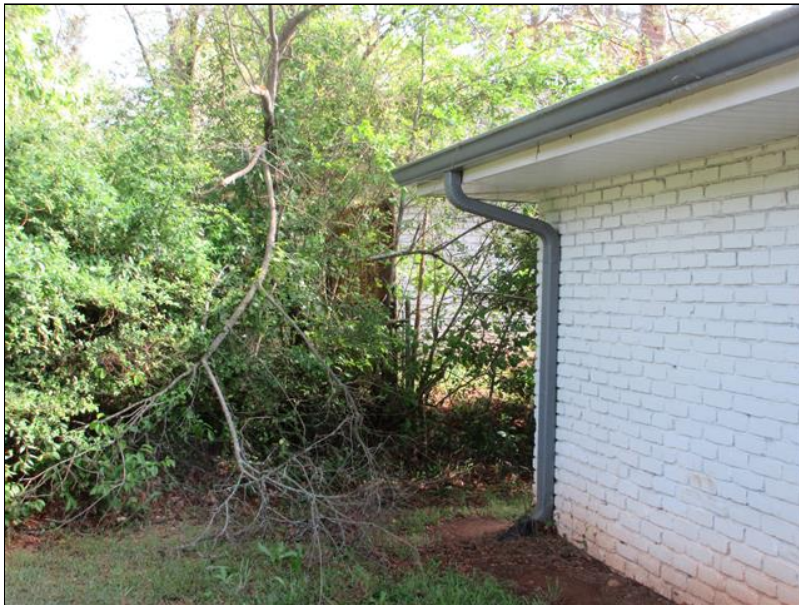
**✘** ♦ **SERVICE / REPAIR:** Overgrown shrubs and vegetation are against the home on the front and right side. This condition promotes insect and pest infestation. Trim the vegetation low and at least two feet from the home.

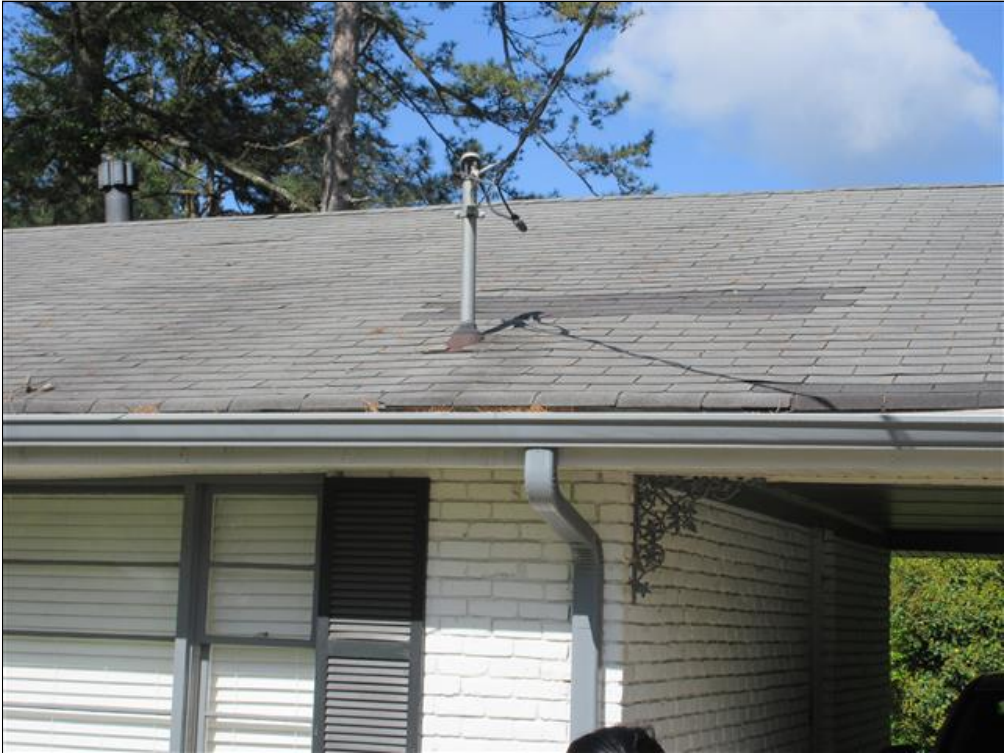
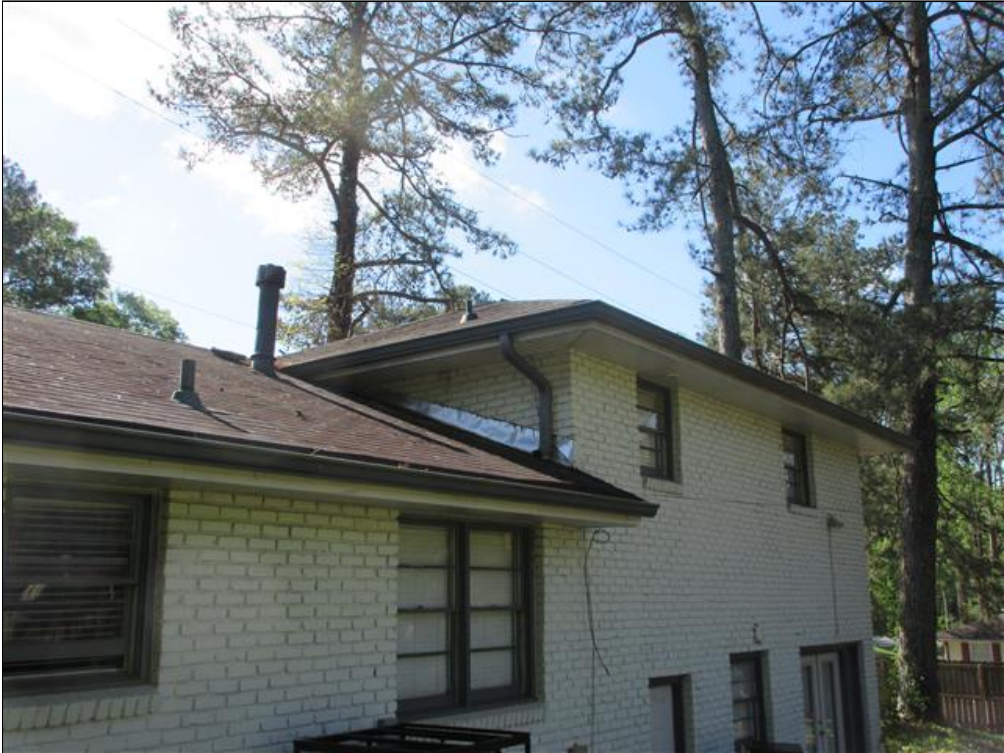
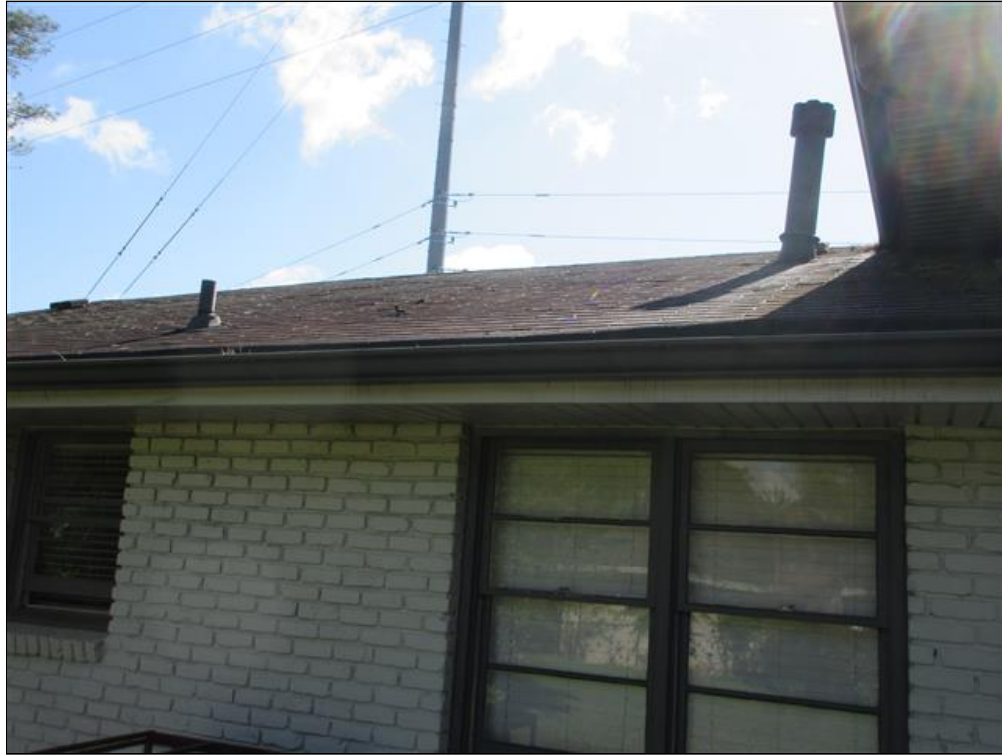
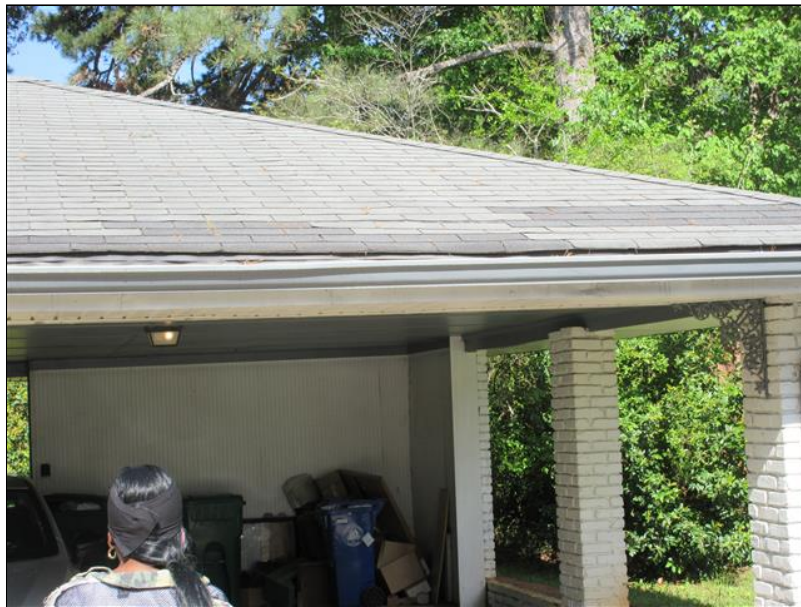
♦ **MAJOR DEFECT:** The roofing is at the end of its useful and predictable life. There are cupped curled shingles, there are stained roof shingles. The roof has been patched in several locations. Budget to replace the roof soon.

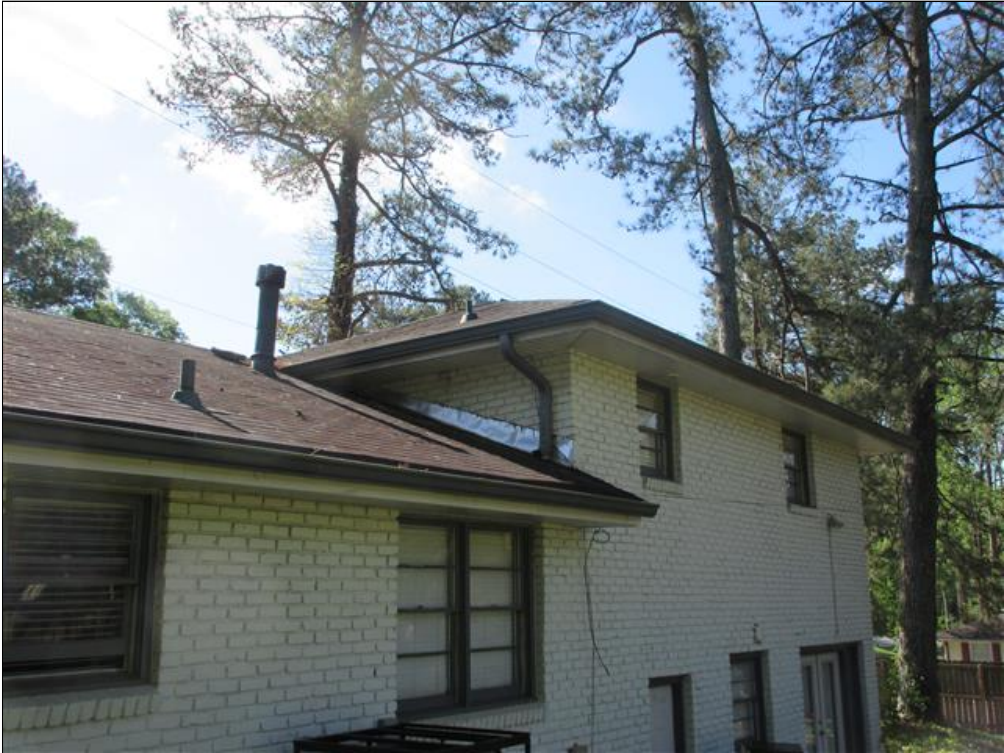
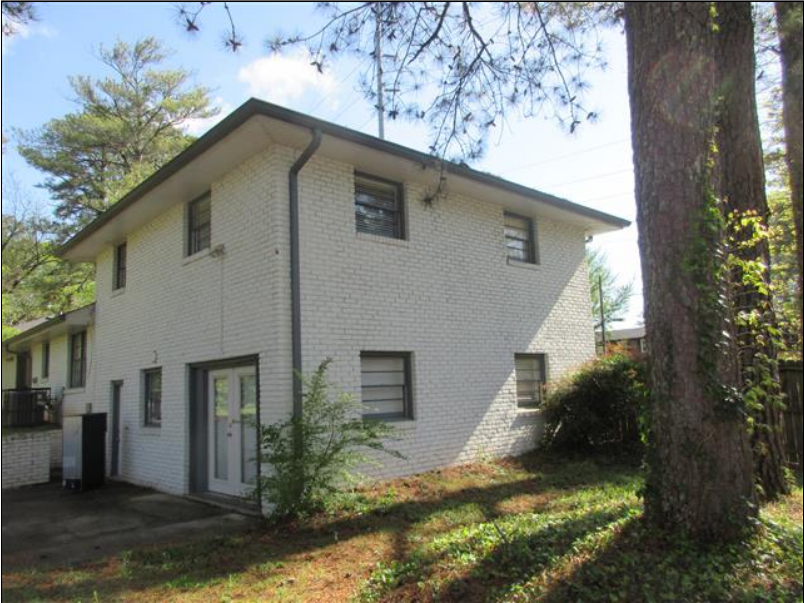
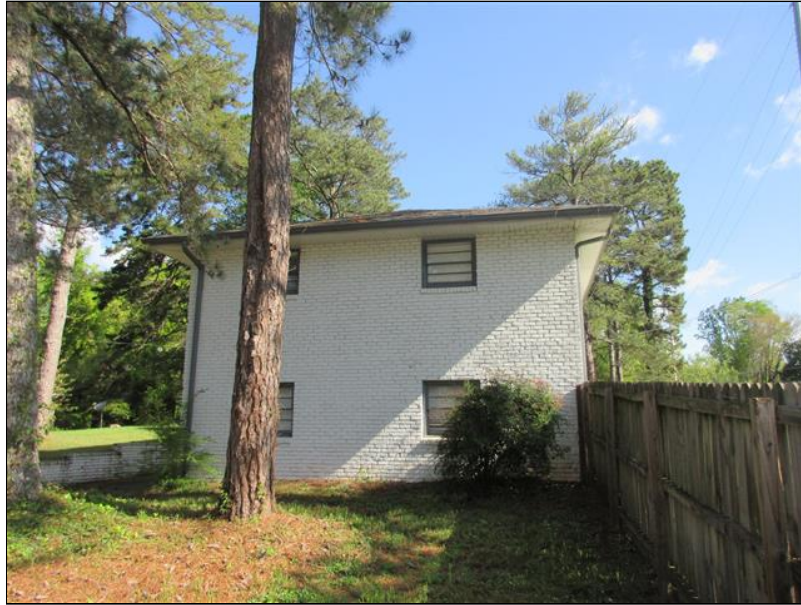
- ❌ ♦ **SERVICE / REPAIR:** Large trees overhang the roof on the left side. Limbs and debris from the trees will damage the roof. The trees provide easy access to the roof and attic for unwanted pest and insects. The trees are nearing the end of life. Remove the trees as required for safety.

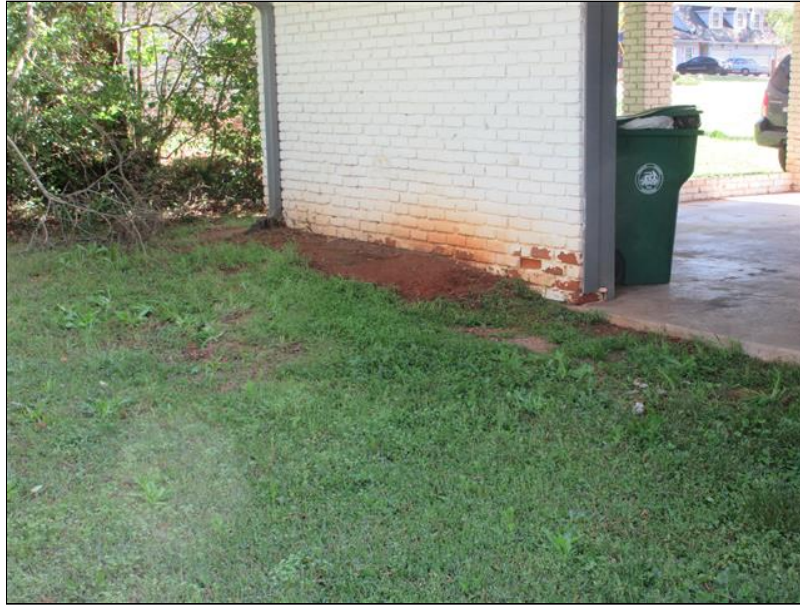
♦ **SERVICE / REPAIR:** Debris present in the gutter system. Cleaning is necessary so that the roof run off will be properly directed away from the home and to prevent water from overflowing and saturating the ground next to the foundation. Sometimes responsible for moisture damage in wood components below.

Install downspout extensions at all downspouts to carry roof runoff water away from the foundation.

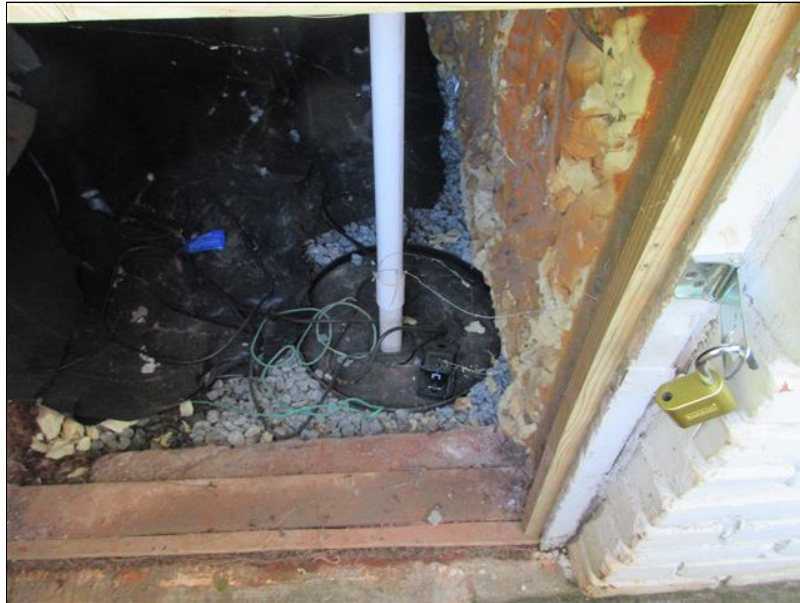
- ✘ ◆ **SERV:** There is a sump pump installed in the crawlspace for foundation water mitigation. The sump pump did not operate. A plumber can repair or replace the sump pump as needed.

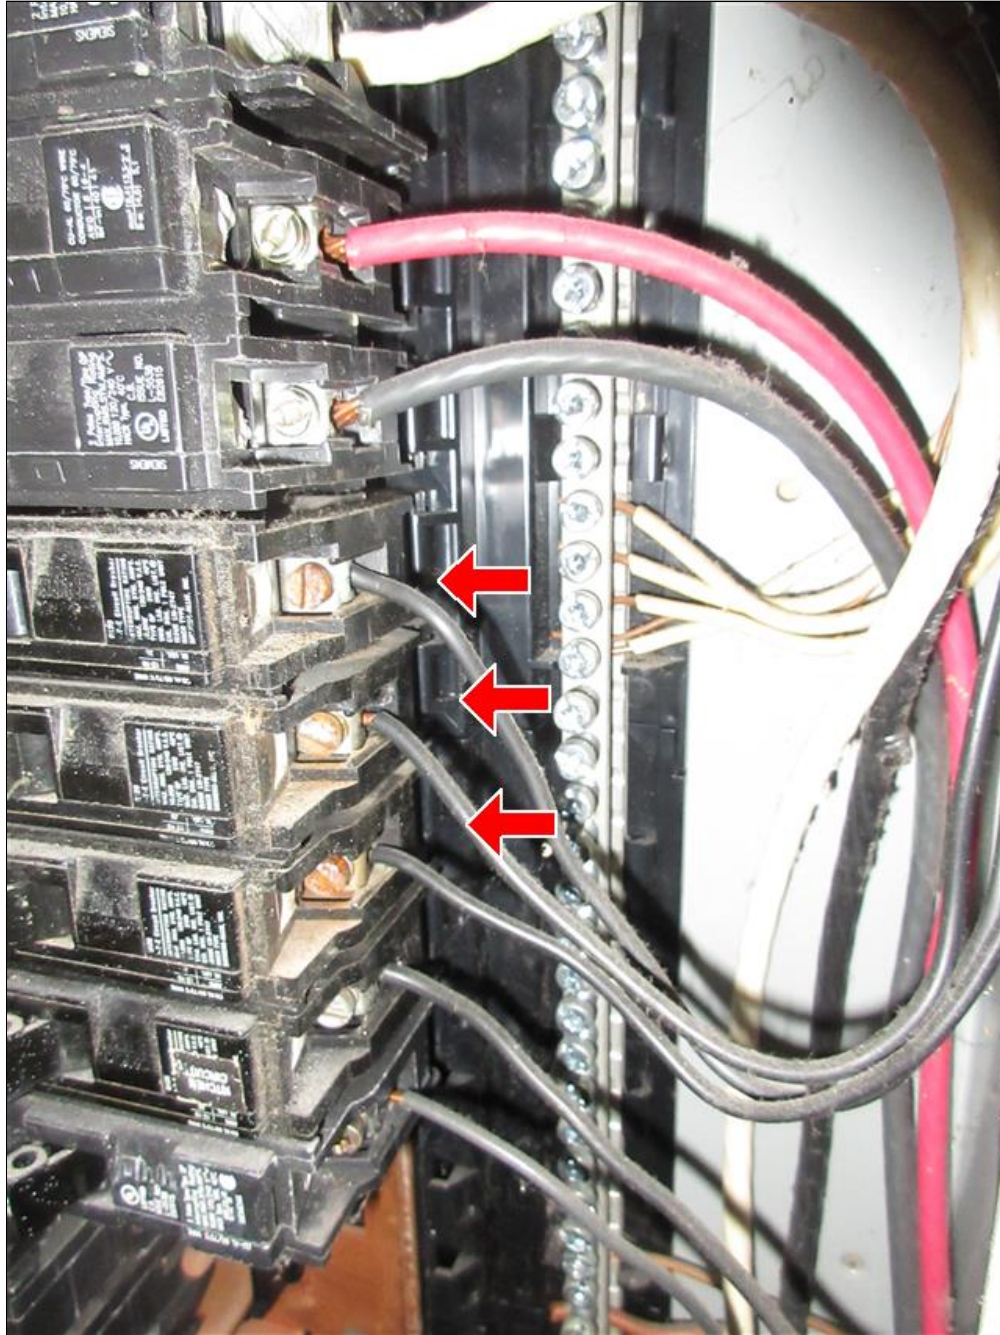
- ✘ ◆ **SERVICE / REPAIR:** There are rusted breakers inside the electric panel. The effected breakers may not trip in an over current condition. An electrician can replace the rusted breakers as required for safety.

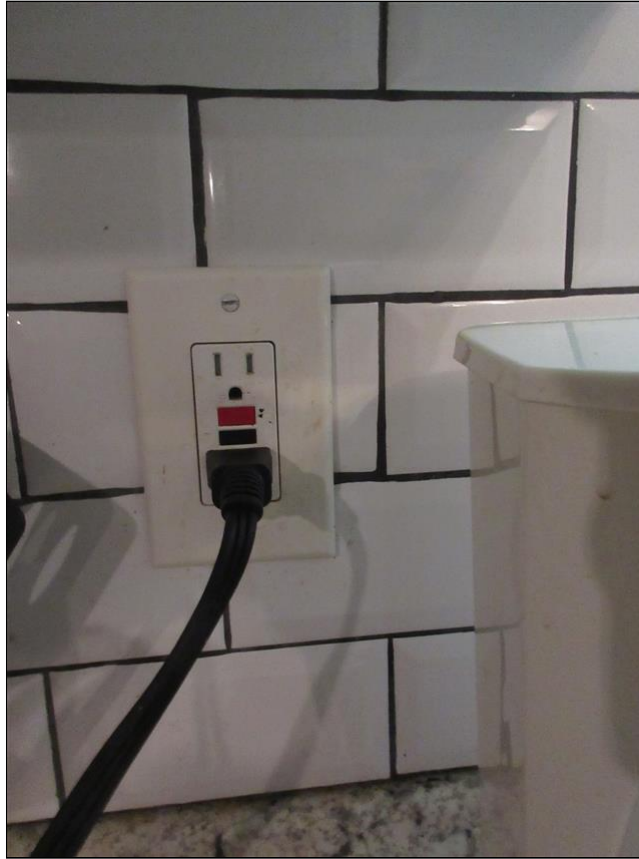
- ♦ **SAFETY / HEALTH:** GFCI device failed to trip when tested with pocket tester or when test button used. While it will still appear to function, it does not provide the required level of safety. Required to be GFCI protected at this location. Replacement with a functional GFCI is necessary by qualified electrician. **LOCATION: left on the kitchen sink**

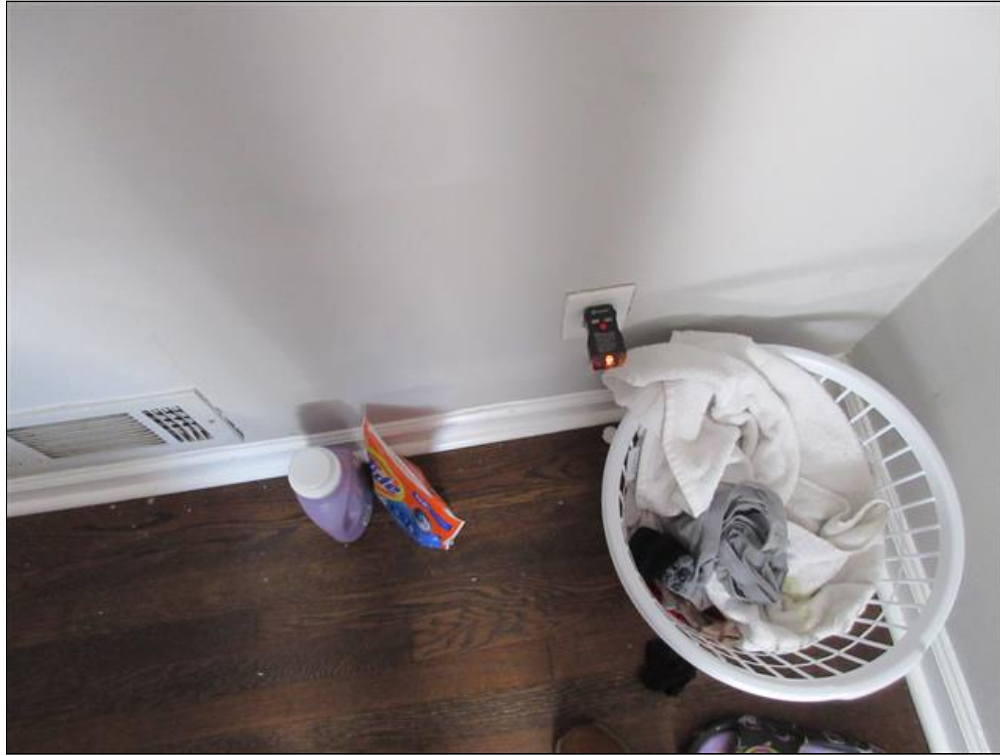
- ❌ ♦ **SERVICE / REPAIR:** There is a ungrounded outlet in a main level front bedroom. This is a safety hazard. An electrician can repair this outlet as required for safety.

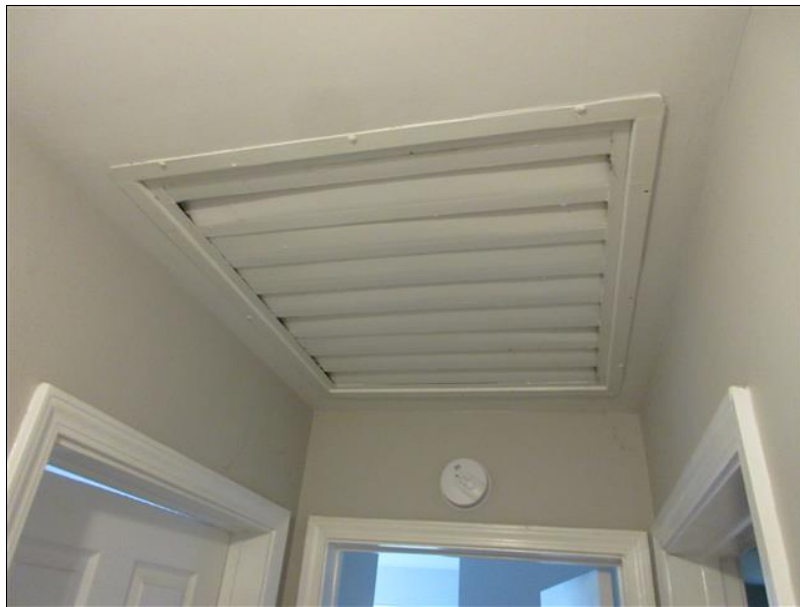
♦ **SERVICE / REPAIR:** The whole house fan is not functional. Repair or replace the whole house fan. Whole house fans can significantly reduce summer cooling cost for the owner.

♦ **SERVICE / REPAIR:** The whole house fan failed to operate when tested during inspection. Repair as needed to allow for normal operation if electing to use routinely.

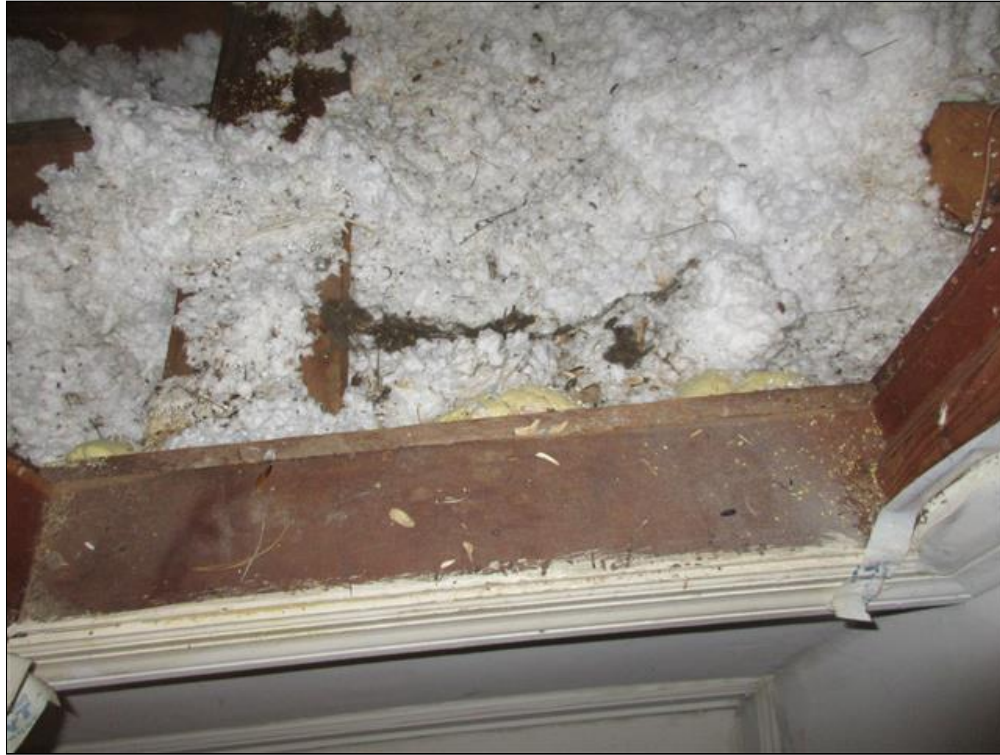
♦ **SERVICE / REPAIR:** There is evidence of pest/rodent activity in the attic. Contact a pest control specialist for remediation.
